Appendix C
Hazardous Materials

Re: Kingsbridge Armory Project
1 West Kingsbridge Road
Block 3247, Lots 2 and 10
CEQR # 25DME006X

The New York City Department of Environmental Protection, Bureau of Sustainability (DEP) has reviewed the February 2025 Draft Environmental Impact Statement Hazardous Materials Chapter and the February 2025 Phase I Environmental Site Assessment (Phase I), prepared by AKRF, Inc. on behalf of the New York City Economic Development Corporation (EDC/applicant). It is our understanding that EDC and the New York City Department of Citywide Administrative Services, are leading a collaborative process to reuse and redevelop a portion of Block 3247 in the Kingsbridge Heights neighborhood of the Bronx (Proposed Project). That portion includes the Kingsbridge Armory (Armory) Site at 1 West Kingsbridge Road (Block 3247, Lot 10), which is currently owned by EDC, and the New York National Guard (National Guard) Site (National Guard Site) at 10 West 195th Street (Block 3247, Lot 2), which is currently owned by the National Guard and occupied by two National Guard buildings (Project Site). The Project Site occupies the portion of Block 3247 that is bounded by West 195t

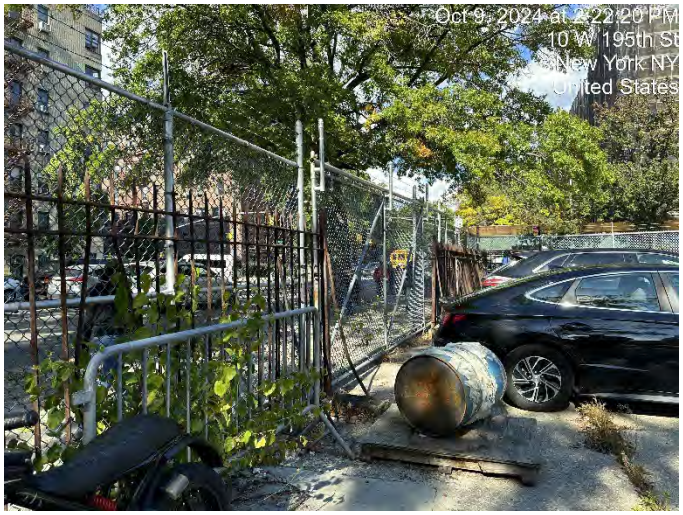
Photograph 34: Dumpsters in the western National Guard parking lot, facing northeast.

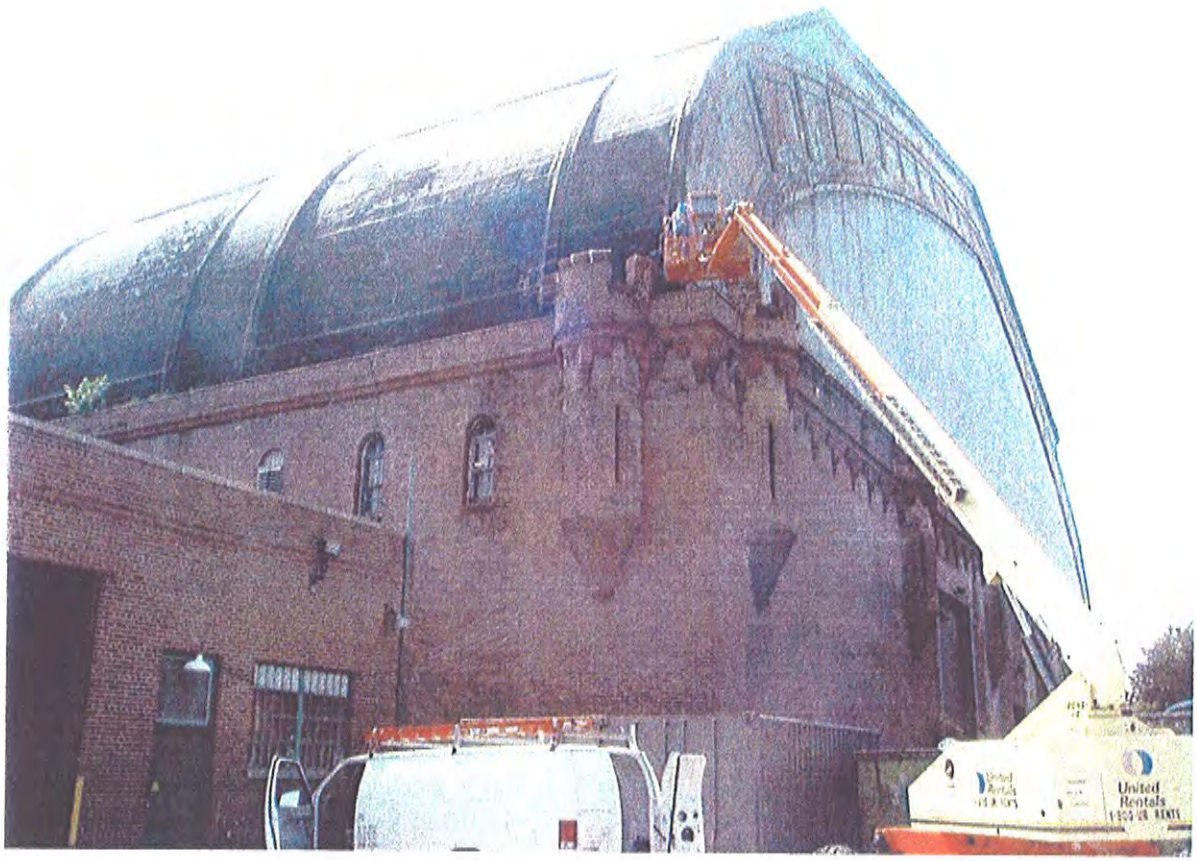
Photograph 6

View of the northwest roof.

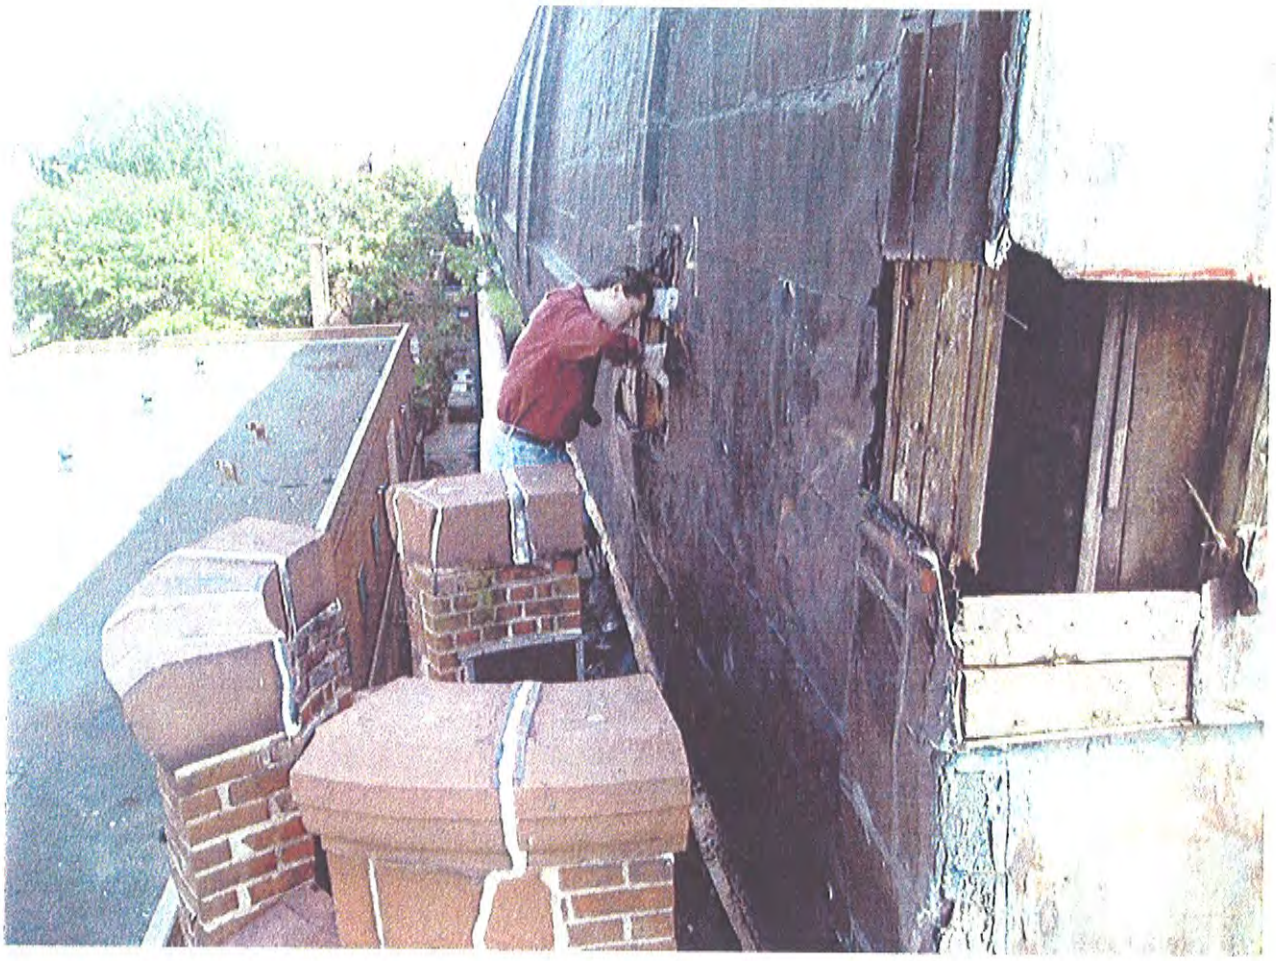
Photograph 7

View of the northwest corner of the roof.

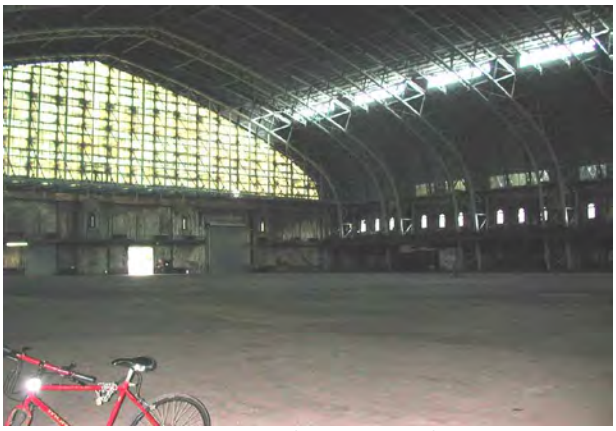
Photo 3: View northwest of the drill hall floor towards Reservoir Avenue. The main entrance to the Armory is in the left-center of the photograph.

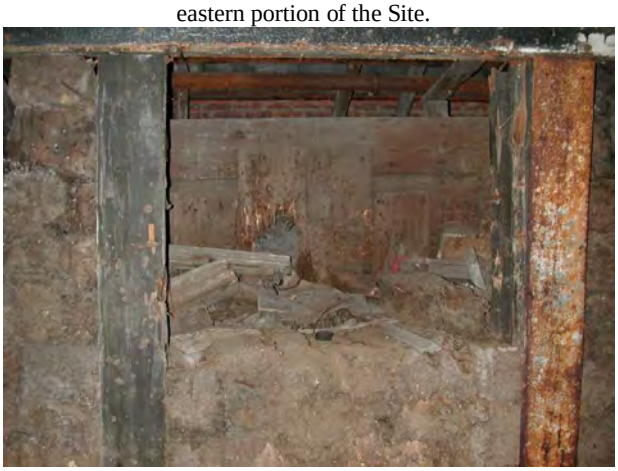
Photo 29: View of deteriorated electrical panel in a sub-floor room located beneath the southern pistol range located on the second level below the drill hall floor near the company rooms.

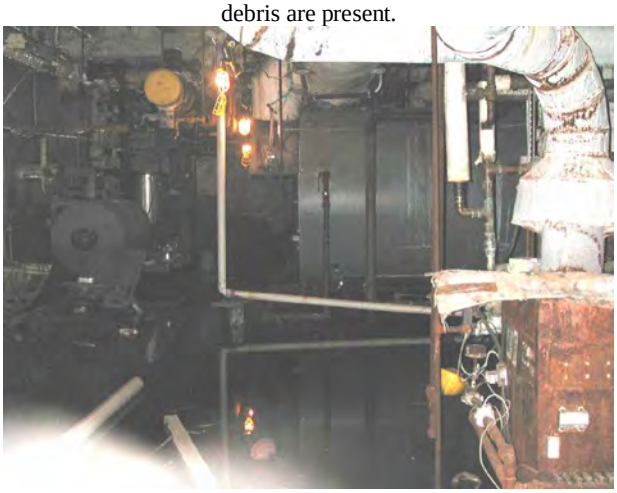
Photo 38: View of debris on the flooded floor of the basement area leading to the boiler room located in the southwestern portion of the Site.

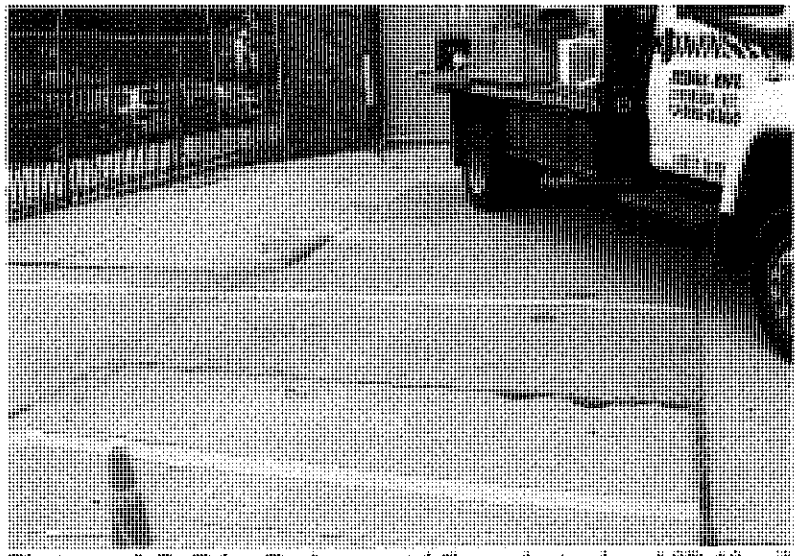
Photograph 6. ADT drilling rig and crew at MW-2 location.

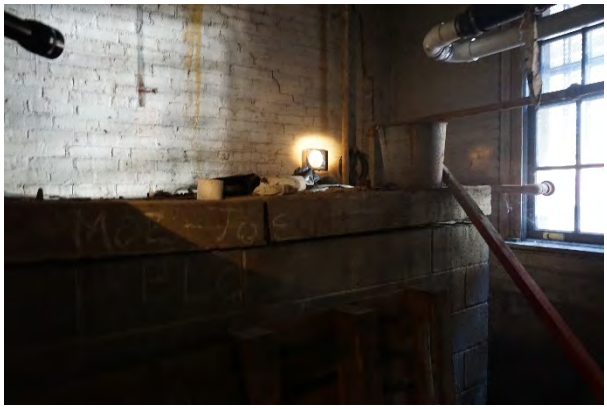
Photograph 20: Boiler room area of Site building.

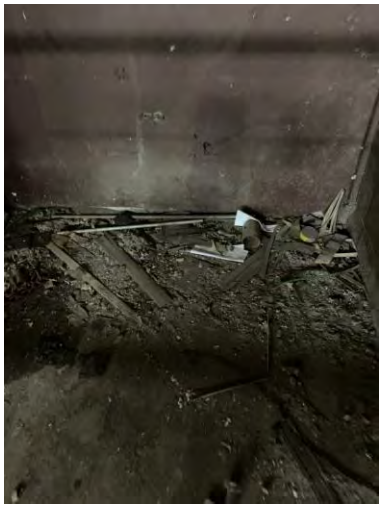
Sample Numbers: 01,02.03 **Material Description:** Floor Debris **Material Color:** Gray **Accessible Material:** Accessible **Asbestos Detected:** Negative **Asbestos Type:** Pending **Homogeneous Area:** 1st Floor **Total Approximate Quantity:** 30 SF **Condition:** Significantly Damaged **Material Type:** Misc. **NESHAP Category:** N/A

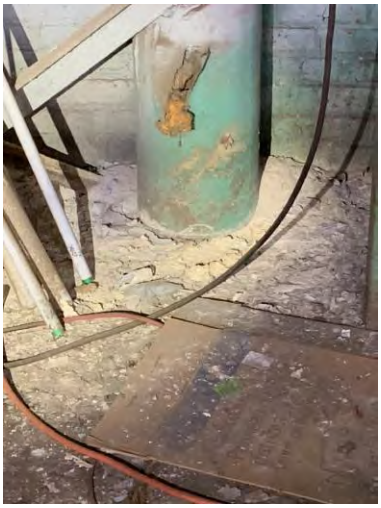
Sample Numbers: 10,11,12 **Material Description:** Floor Debris **Material Color:** Gray **Accessible Material:** Accessible **Asbestos Detected:** Positive **Asbestos Type:** Chrysotile **Homogeneous Area:** 1st Floor **Total Approximate Quantity:** 80 SF **Condition:** Significantly Damaged **Material Type:** Misc. **NESHAP Category:** RACM

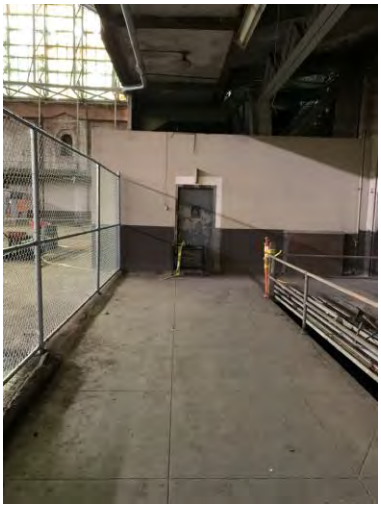
Sample Numbers: 28,29,30 **Material Description:** Floor Debris **Material Color:** Gray **Accessible Material:** Accessible **Asbestos Detected:** Negative **Asbestos Type:** Pending **Homogeneous Area:** 1st Floor **Total Approximate Quantity:** 80 SF **Condition:** Significantly Damaged **Material Type:** Misc. **NESHAP Category:** N/A	
Sample Numbers: N/A **Material Description:** Debris **Material Color:** Gray **Accessible Material:** Inaccessible **Reason Inaccessible:** Not included in the Scope **Asbestos Detected:** Pending **Asbestos Type:** Inaccessible Material **Homogeneous Area:** Southeast Side **Total Approximate Quantity:** TBD **Condition:** N/A **Material Type:** N/A **NESHAP Category:** N/A

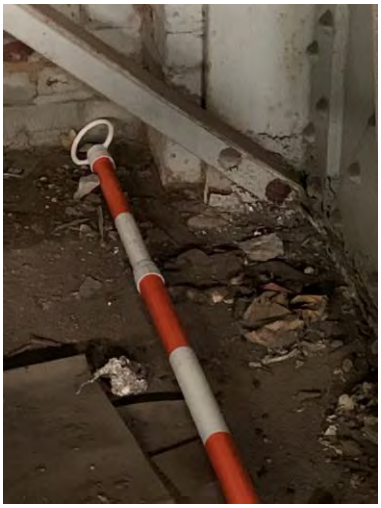
Sample Numbers: 43,44,45 **Material Description:** Debris on Floor **Material Color:** Gray **Accessible Material:** Accessible **Asbestos Detected:** Negative **Asbestos Type:** Pending **Homogeneous Area:** 1st Floor **Total Approximate Quantity:** 80 SF **Condition:** Significantly Damaged **Material Type:** Misc. **NESHAP Category:** N/A

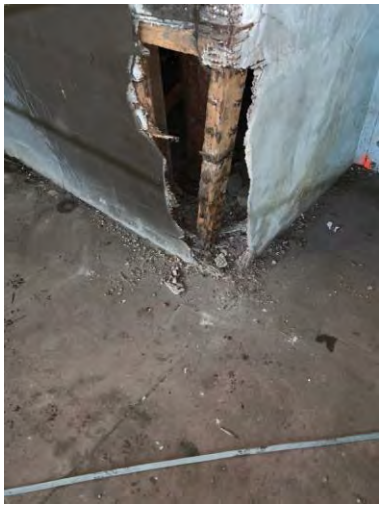
Sample Numbers: 55,56,57 **Material Description:** Debris on Floor **Material Color:** Gray **Accessible Material:** Accessible **Asbestos Detected:** Negative **Asbestos Type:** Pending **Homogeneous Area:** 1st Floor **Total Approximate Quantity:** 80 SF **Condition:** Significantly Damaged **Material Type:** Misc. **NESHAP Category:** N/A	
Sample Numbers: 58,59,60 **Material Description:** Debris on Floor **Material Color:** Gray **Accessible Material:** Accessible **Asbestos Detected:** Positive **Asbestos Type:** Chrysotile **Homogeneous Area:** 1st Floor **Total Approximate Quantity:** 480 SF **Condition:** Significantly Damaged **Material Type:** Misc. **NESHAP Category:** RACM

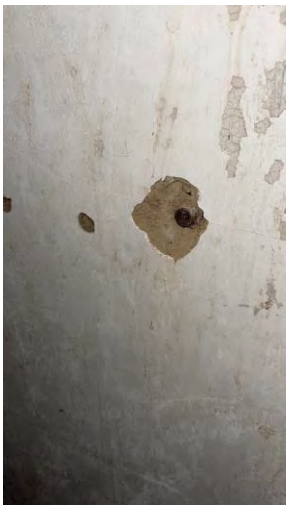
Sample Numbers: 19, 20, 21, 22, 23, 24, 25, 26, 27 **Material Description:** Wall Plaster - Outer Layer **Material Color:** White **Accessible Material:** Accessible **Asbestos Detected:** Negative **Asbestos Type:** No Asbestos Detected **Homogeneous Area:** Lobby **Total Approximate Quantity:** 2,200 SF **Condition:** Good **Material Type:** Surfacing

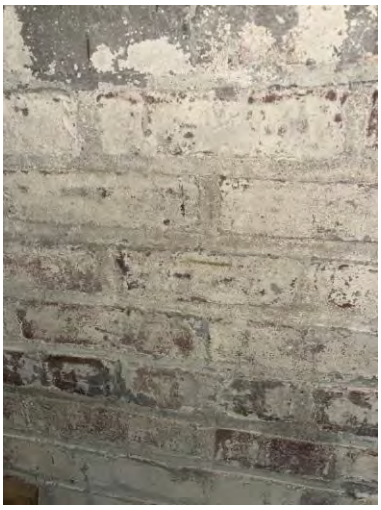
Sample Numbers: 25, 26, 27, 28, 29, 30, 31, 32, 33
Material Description: Coating Surfacing Material - Bottom Layer
Material Color: Whited
Accessible Material: Accessible
Asbestos Detected: Negative
Asbestos Type: No Asbestos Detected
Homogeneous Area: Assembly Area and Balconies Walls
Total Approximate Quantity: 61,200 SF
Condition: Significantly Damaged
Material Type: Surfacing

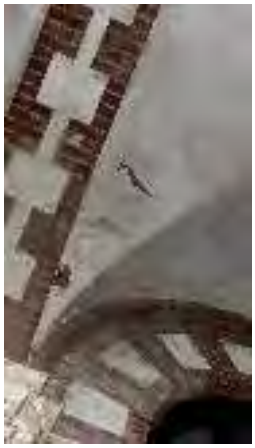
Sample Numbers: LCP- 01 **Sample Location:** Lobby Ceiling **Description:** Light Gray Paint **Laboratory Result (%): 9.75 % Lead** **Substrate:** Plaster **Paint Locations:** Throughout **Quantity of Deteriorated Paint (SF):** TBD

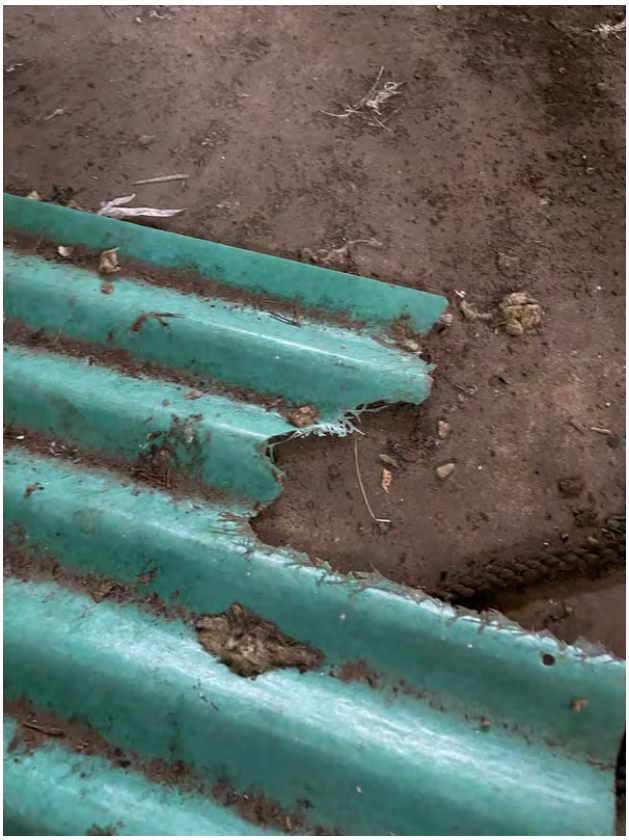
Sample Numbers: 01, 02, 03
Material Description: Green Window Fiber Corrugated Panels
Material Color: Green
Accessible Material: Accessible
Asbestos Detected: Negative
Asbestos Type: No Asbestos Detected
Homogeneous Area: North Balcony
Total Approximate Quantity: 2,500 SF
Condition: Significantly Damaged
Material Type: Misc.

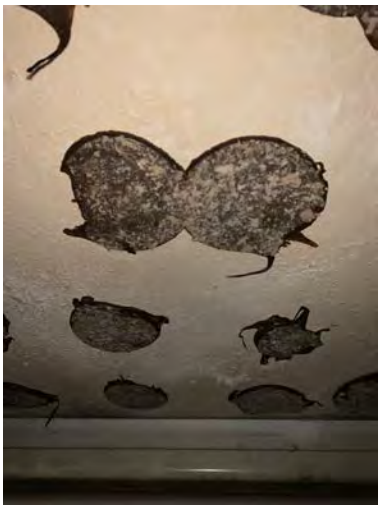
Sample Numbers: 94, 95 **Material Description:** Glue Dollops Associated With Ceiling Tiles **Material Color:** Brown **Accessible Material:** Accessible **Asbestos Detected:** Negative **Asbestos Type:** No Asbestos Detected **Homogeneous Area:** First Floor / Drill Floor - Room 1W-8 **Total Approximate Quantity:** 200 SF **Condition:** Significantly Damaged **Material Type:** Misc.

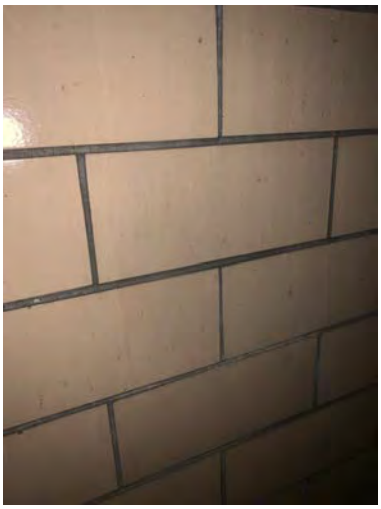
Sample Numbers: 99, 100, 101 **Material Description:** Glazed Brick Mortar **Material Color:** Grey **Accessible Material:** Accessible **Asbestos Detected:** Negative **Asbestos Type:** No Asbestos Detected **Homogeneous Area:** First Floor / Drill Floor - Restrooms / Locker Room **Total Approximate Quantity:** 2,200 SF **Condition:** Significantly Damaged **Material Type:** Misc.

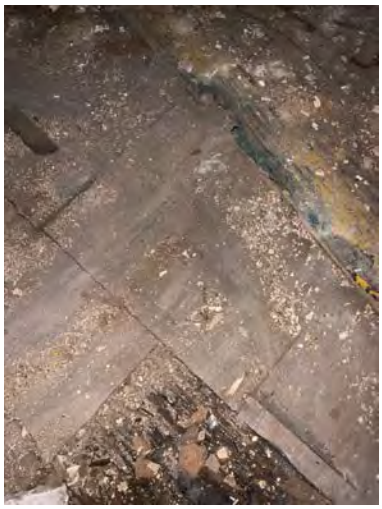
Sample Numbers: 108, 109 **Material Description:** 12x12 Floor Tile **Material Color:** Wood Grain Pattern **Accessible Material:** Accessible **Asbestos Detected:** Positive **Asbestos Type:** 9.00% Chrysotile **Homogeneous Area:** First Floor / Drill Floor - Room 1W-6 **Condition:** Significantly Damaged **Material Type:** Misc. **NESHAP Category:** RACM

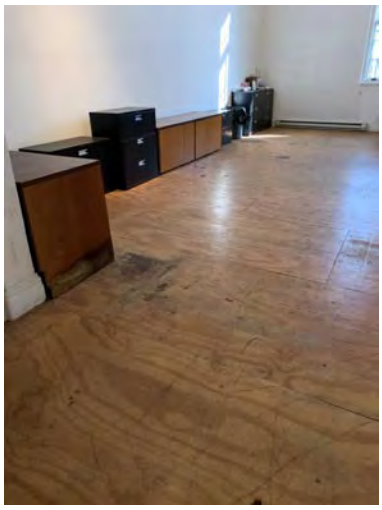
Sample Numbers: 120, 121 **Material Description:** 9x9 Floor Tile **Material Color:** Brown **Accessible Material:** Accessible **Asbestos Detected:** Positive **Asbestos Type:** 5.90% Chrysotile **Homogeneous Area:** First Floor / Drill Floor - Room 1W-3, First Floor / Drill Floor - Room 1E-2, First Floor / Drill Floor-Room 1E-4 East & West Storage Rooms - Bottom Layer, First Floor / Drill Floor - Room 1E-1 **Condition:** Significantly Damaged **Material Type:** Misc. **NESHAP Category:** RACM	
Sample Numbers: N/A **Material Description:** Assume ACM Floor – No Access Under The Plywood Floor **Material Color:** Not Indicated **Accessible Material:** Inaccessible **Reason Inaccessible:** No Access – Solid Flooring **Asbestos Detected:** Pending **Asbestos Type:** Inaccessible Material **Homogeneous Area:** First Floor / Drill Floor - Room 1W-2 **Total Approximate Quantity:** 800 SF **Material Type:** Misc.

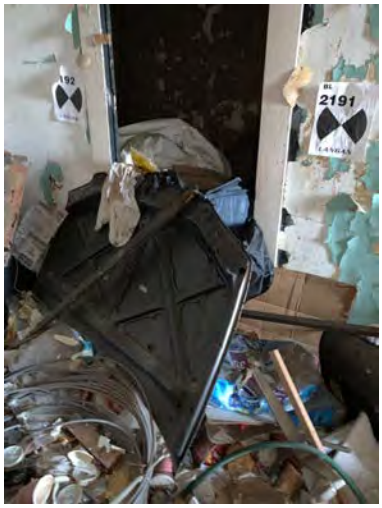
Sample Numbers: N/A **Material Description:** East & West Storage Rooms-No Access **Material Color:** Not Indicated **Accessible Material:** Non-Suspect **Reason Inaccessible:** Piled with Waste Materials **Homogeneous Area:** First Floor / Drill Floor - Rooms: 1W-1 To 1W-6 And 1E-1 To 1E-6 - Limited Access.

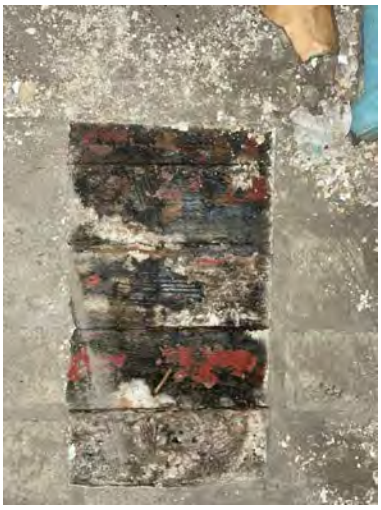
Sample Numbers: 159, 160, 202 **Material Description:** 9x9 Floor Tile **Material Color:** Brown **Accessible Material:** Accessible **Asbestos Detected:** Positive **Asbestos Type:** 4.40% Chrysotile **Homogeneous Area:** 1st Floor Mezzanine Room EM-6, 1st Floor Mezzanine Room EM-5, 1st Floor Mezzanine Room EM-4, 1st Floor Mezzanine Room EM-3, 1st Floor Mezzanine Room EM-2, Second Floor 2SW-5, 2SW-4, 2SW-3, 2SW-2, Second Floor 2SE-3, Second Floor 2SE-6, Second Floor 2SE-7, 3rd Floor West Tower **Condition:** Significantly Damaged **Material Type:** Misc. **NESHAP Category:** RACM	
Sample Numbers: 161, 162 **Material Description:** Mastic for 12x12 Linoleum Tile **Material Color:** Black **Accessible Material:** Accessible **Asbestos Detected:** Positive **Asbestos Type:** 2.00% Chrysotile **Homogeneous Area:** 1st Floor Mezzanine Room EM-1 **Condition:** Significantly Damaged **Material Type:** Misc. **NESHAP Category:** RACM

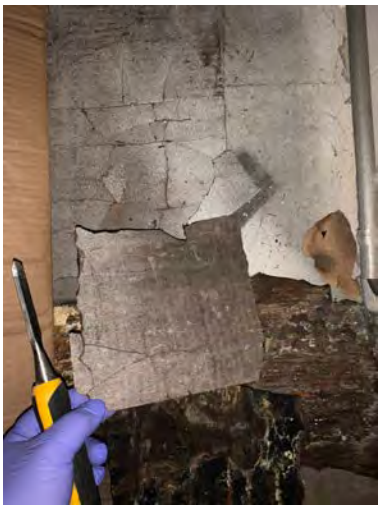
Sample Numbers: 171, 172, 206 **Material Description:** 9x9 Floor Tile **Material Color:** Grey **Accessible Material:** Accessible **Asbestos Detected:** Positive **Asbestos Type:** 4.30% Chrysotile **Homogeneous Area:** 1st Floor Mezzanine Room WM-3, Second Floor 2SE-1A & 2SE-1B, Second Floor SET-1 **Condition:** Significantly Damaged **Material Type:** Misc. **NESHAP Category:** RACM

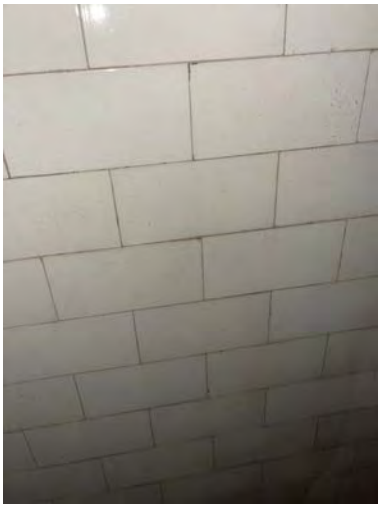
Sample Numbers: 175, 176, 177 **Material Description:** Wall Ceramic Tile Grout **Material Color:** Grey **Accessible Material:** Accessible **Asbestos Detected:** Negative **Asbestos Type:** No Asbestos Detected **Homogeneous Area:** 1st Floor Mezzanine - 12 Bathrooms , Second Floor & Third Floor - 10 Bathrooms **Total Approximate Quantity:** 3804 SF **Condition:** Significantly Damaged **Material Type:** Misc.

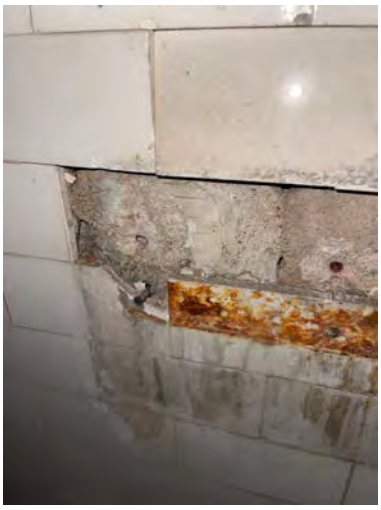
Sample Numbers: 178, 179, 180 **Material Description:** Wall Ceramic Tile Mortar **Material Color:** Grey **Accessible Material:** Accessible **Asbestos Detected:** Negative **Asbestos Type:** No Asbestos Detected **Homogeneous Area:** 1st Floor Mezzanine - 12 Bathrooms , Second Floor & Third Floor - 10 Bathrooms **Total Approximate Quantity:** 3,804 SF **Condition:** Significantly Damaged **Material Type:** Misc.

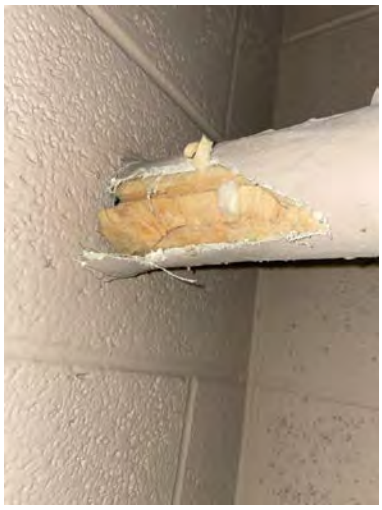
Sample Numbers: 187, 188, 189 **Material Description:** Aircell Pipe Insulation **Material Color:** Grey **Accessible Material:** Accessible **Asbestos Detected:** Positive **Asbestos Type:** 33.00% Chrysotile **Homogeneous Area:** Throughout **Condition:** Significantly Damaged **Material Type:** Misc. **NESHAP Category:** RACM	
Sample Numbers: 190, 191, 192 **Material Description:** Fiberglass Pipe Insulation Wrapping Paper **Material Color:** Tan **Accessible Material:** Accessible **Asbestos Detected:** Negative **Asbestos Type:** No Asbestos Detected **Homogeneous Area:** Throughout **Total Approximate Quantity:** 10,920 LF **Condition:** Significantly Damaged **Material Type:** Misc.

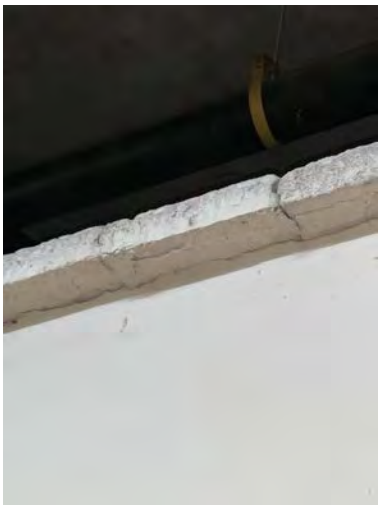
Sample Numbers: 196, 197, 198 **Material Description:** Ceiling Panels **Material Color:** Grey **Accessible Material:** Accessible **Asbestos Detected:** Negative **Asbestos Type:** No Asbestos Detected **Homogeneous Area:** First Floor / Drill Floor Electrical Rooms Structure **Total Approximate Quantity:** 400 SF **Condition:** Damaged **Material Type:** Surfacing

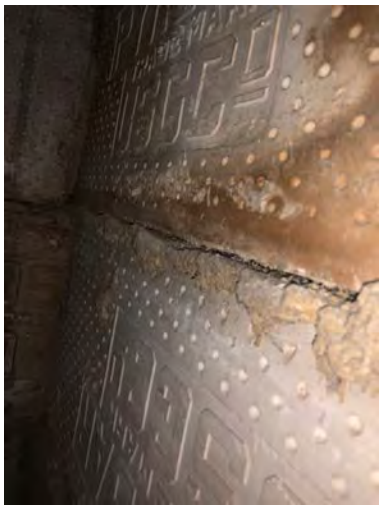
Sample Numbers: 213, 214 **Material Description:** Terra-Cotta Brick Mortar **Material Color:** Grey **Accessible Material:** Accessible **Asbestos Detected:** Negative **Asbestos Type:** No Asbestos Detected **Homogeneous Area:** Throughout **Total Approximate Quantity:** 3,400 SF **Condition:** Significantly Damaged **Material Type:** Misc.	
Sample Numbers: 215, 216 **Material Description:** Terra-Cotta Brick **Material Color:** Tan **Accessible Material:** Accessible **Asbestos Detected:** Negative **Asbestos Type:** No Asbestos Detected **Homogeneous Area:** Throughout **Total Approximate Quantity:** 4,600 SF **Condition:** Significantly Damaged **Material Type:** Misc.

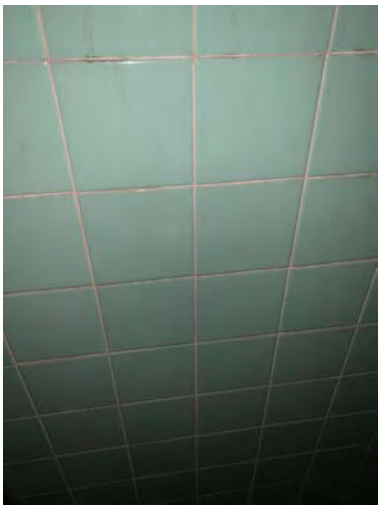
Sample Numbers: 217, 218 **Material Description:** Terra-Cotta Brick Mortar **Material Color:** Grey **Accessible Material:** Accessible **Asbestos Detected:** Negative **Asbestos Type:** No Asbestos Detected **Homogeneous Area:** Throughout **Total Approximate Quantity:** 5,500 SF **Condition:** Significantly Damaged **Material Type:** Misc.	
Sample Numbers: 219, 220 **Material Description:** Wall Ceramic Tile Grout **Material Color:** White **Accessible Material:** Accessible **Asbestos Detected:** Positive **Asbestos Type:** 3.00% Chrysotile **Homogeneous Area:** Second Floor Two (2) Bathrooms on Main Stairs **Condition:** Significantly Damaged **Material Type:** Misc. **NESHAP Category:** RACM

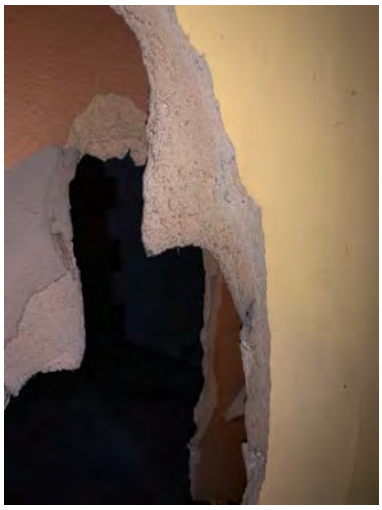
Sample Numbers: 225, 226 **Material Description:** Tar Paper Above Ceiling **Material Color:** Black **Accessible Material:** Accessible **Asbestos Detected:** Negative **Asbestos Type:** No Asbestos Detected **Homogeneous Area:** 2nd Floor **Total Approximate Quantity:** 12 SF **Condition:** Significantly Damaged **Material Type:** Misc.	
Sample Numbers: 227, 228 **Material Description:** Wall Card Board **Material Color:** Grey **Accessible Material:** Accessible **Asbestos Detected:** Negative **Asbestos Type:** No Asbestos Detected **Homogeneous Area:** 2nd Floor Throughout **Total Approximate Quantity:** 28,000 SF **Condition:** Significantly Damaged **Material Type:** Misc.

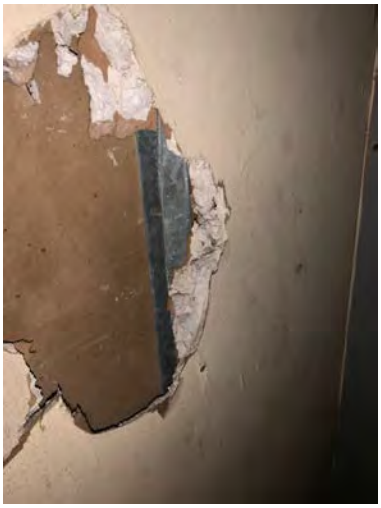
Sample Numbers: 241, 242, 243 **Material Description:** Drywall **Material Color:** Grey **Accessible Material:** Accessible **Asbestos Detected:** Negative **Asbestos Type:** No Asbestos Detected **Homogeneous Area:** Basement & Basement Mezzanine **Total Approximate Quantity:** 16,800 SF **Condition:** Significantly Damaged **Material Type:** Misc.

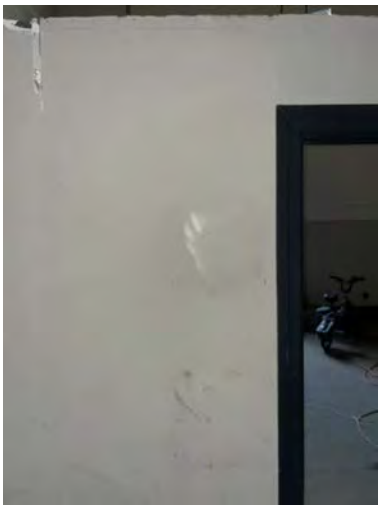
Sample Numbers: 258, 259, 260 **Material Description:** Drywall **Material Color:** Grey **Accessible Material:** Accessible **Asbestos Detected:** Negative **Asbestos Type:** No Asbestos Detected **Homogeneous Area:** First Floor / Drill Floor **Total Approximate Quantity:** 800 SF **Condition:** Significantly Damaged **Material Type:** Misc.

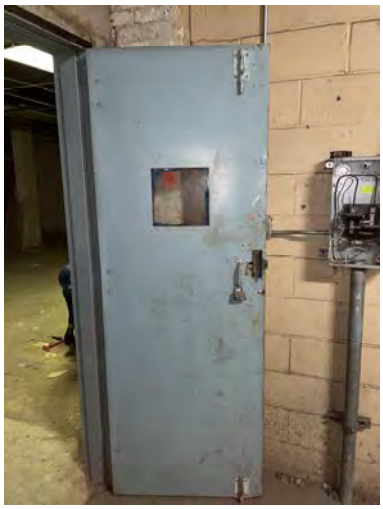
Sample Numbers: N/A **Material Description:** Metal Fire Door Insulation **Material Color:** Multiple **Accessible Material:** Inaccessible **Reason Inaccessible:** Not Able to Access Safely **Asbestos Detected:** Pending **Asbestos Type:** Inaccessible Material **Homogeneous Area:** Throughout **Total Approximate Quantity:** 850 Each **Condition:** Damaged **Material Type:** Misc.

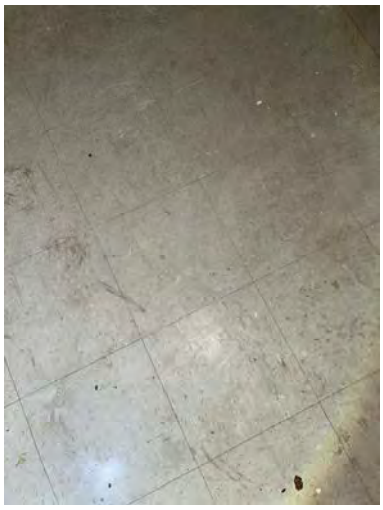
Sample Numbers: 305,306 **Material Description:** Adhesive for 12"x12" Gray Floor Tile **Material Color:** Yellow **Accessible Material:** Accessible **Asbestos Detected:** Trace **Asbestos Type:** Trace (<1% Chrysotile) **Homogeneous Area:** Basement Mezzanine - Room B-18 **Total Approximate Quantity:** 850 SF **Condition:** Good **Material Type:** Misc.	
Sample Numbers: 307,308 **Material Description:** 12"x12" Floor Tile **Material Color:** Grey **Accessible Material:** Accessible **Asbestos Type:** No Asbestos Detected **Homogeneous Area:** Basement Mezzanine - Room B-18 **Total Approximate Quantity:** 850 SF **Condition:** Good **Material Type:** Misc. **Notes:** Top Layer

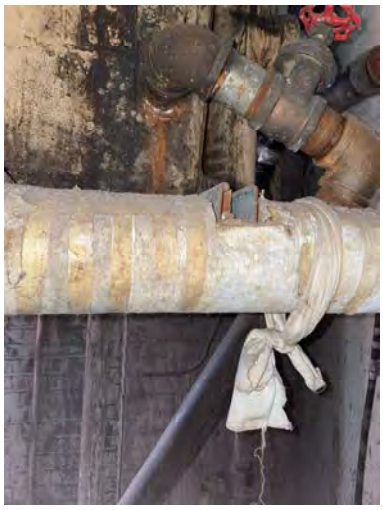
Sample Numbers: 324,325 **Material Description:** Covebase **Material Color:** Grey **Accessible Material:** Accessible **Asbestos Detected:** Negative **Asbestos Type:** No Asbestos Detected **Homogeneous Area:** Basement Mezzanine - Room B-18 **Total Approximate Quantity:** 15 SF **Condition:** Good **Material Type:** Misc. **NESHAP Category:** N/A **Notes:** Not Applicable	
Sample Numbers: 326,327,328 **Material Description:** Fiberglass Pipe Insulation Wrap Paper **Material Color:** White **Accessible Material:** Accessible **Asbestos Detected:** Negative **Asbestos Type:** No Asbestos Detected **Homogeneous Area: B**asement Mezzanine - Northeast Offices **Total Approximate Quantity:** 840 LF **Condition:** Good **Material Type:** TSI

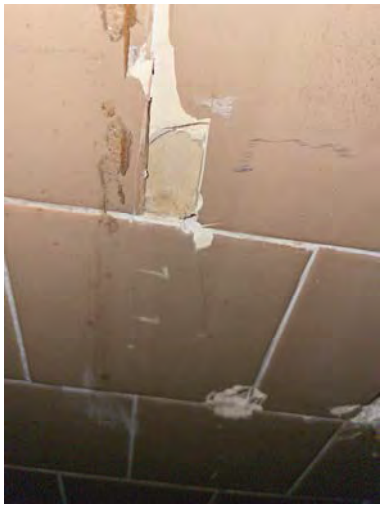
Sample Numbers: 337,338 **Material Description:** 4"x4" Wall Ceramic Tile **Material Color:** Grey Mortar, **Accessible Material:** Accessible **Asbestos Detected:** Negative **Asbestos Type:** No Asbestos Detected **Homogeneous Area:** Basement Mezzanine - Northeast Offices Shower/bathroom, Bathrooms, Kitchen **Total Approximate Quantity:** 3,700 SF **Condition:** Good **Material Type:** Misc.

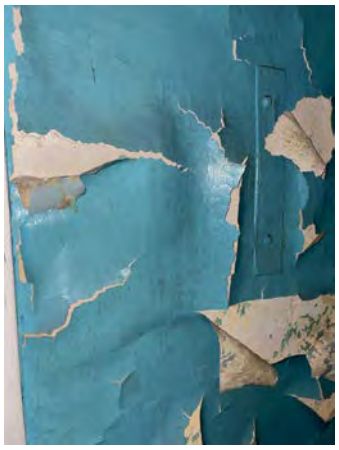
Sample Numbers: LCP - 13 **Sample Location:** Walls And Ceilings **Description:** Blue Paint **Laboratory Result (%):** 11 % weight **Substrate:** Plaster **Paint Locations:** First Floor / Drill Floor - West Side W-1 Mezzanine

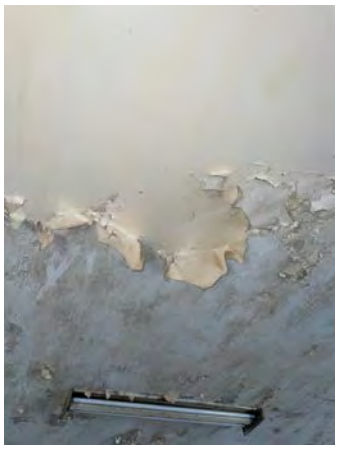
KINGSBRIDGE ARMORY LEAD PAINT SURVEY LEAD PAINT SAMPLING PHOTOGRAPHIC LOG APRIL 17th to APRIL 25th, 2023	
Sample Numbers: LCP - 22 **Sample Location:** Ceiling **Description:** Tan Color Paint **Laboratory Result (%):** 16 % weight **Substrate:** Plaster **Paint Locations:** 2nd Floor East And West Side Staircases And East And West Side Rooms Walls	
Sample Numbers: LCP - 23 **Sample Location:** Ceiling **Description:** Beige Color Paint **Laboratory Result (%):** 24 % weight **Substrate:** Plaster **Paint Locations:** 2nd Floor East Side Lounge Ceiling Room# 1A

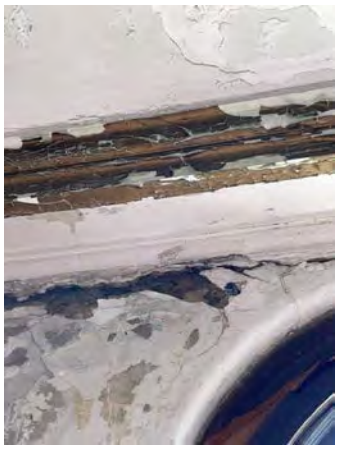
Sample Numbers: LCP - 25 **Sample Location:** Door And Frames **Description:** Tan Color Paint **Laboratory Result (%):** 0.82 % weight **Substrate:** Metal **Paint Locations:** 2nd Floor East Side Closet Next To Bar Room 1B	
Sample Numbers: LCP - 26 **Sample Location:** Ceiling **Description:** Gold Color Paint **Laboratory Result (%):** 30 % weight **Substrate:** Plaster **Paint Locations:** 2nd Floor West Side Room # 7 Ceiling Molding

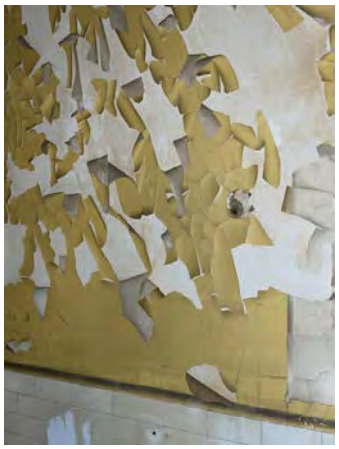
KINGSBRIDGE ARMORY LEAD PAINT SURVEY LEAD PAINT SAMPLING PHOTOGRAPHIC LOG APRIL 17th to APRIL 25th, 2023	
Sample Numbers: LCP - 28 **Sample Location:** Walls **Description:** Red Color Paint **Laboratory Result (%):** 41 % weight **Substrate:** Plaster **Paint Locations:** 2nd Floor West Side Rooms W-3 And East Side Room E-1	
Sample Numbers: LCP - 29 **Sample Location:** Walls **Description:** Yellow Color Paint **Laboratory Result (%):** 31 % weight **Substrate:** Plaster **Paint Locations:** 2nd Floor West Side Rooms # W2 Restroom

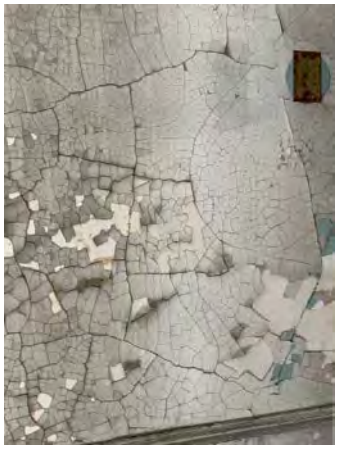
KINGSBRIDGE ARMORY LEAD PAINT SURVEY LEAD PAINT SAMPLING PHOTOGRAPHIC LOG APRIL 17th to APRIL 25th, 2023	
Sample Numbers: LCP - 31 **Sample Location:** Walls **Description:** Tan Color Paint **Laboratory Result (%):** 9.8 % weight **Substrate:** Plaster **Paint Locations:** Throughout 3rd Floor SWEIGHT-1 And SET-1 Staircases And Walls	
Sample Numbers: LCP - 32 **Sample Location:** Walls **Description:** Brown Color Paint **Laboratory Result (%):** 38 % weight **Substrate:** Plaster **Paint Locations:** Throughout 3rd Floor SWEIGHT-1 And SET-1 Staircases And Walls	
Sample Numbers: LCP - 33 **Sample Location:** Walls **Description:** Gray Color Paint **Laboratory Result (%):** 29 % weight **Substrate:** Plaster **Paint Locations:** Walls 4th And 5th Floor East And West Towers

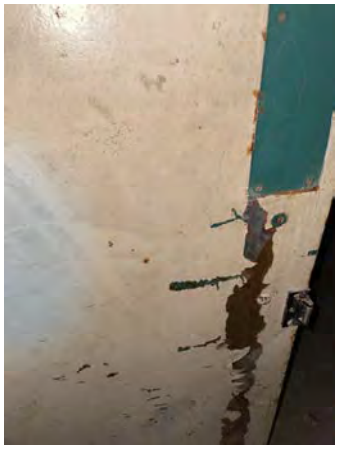
Sample Numbers: LCP-46 **Sample Location:** Sub-Basement Mezzanine- Northeast Mechanical Room **Description:** Beige Paint On Plaster Wall **Laboratory Result (%):** 21 % weight **Substrate:** Plaster **Paint Locations:** Sub-Basement Mezzanine- Northeast Mechanical Room	
Sample Numbers: LCP-47 **Sample Location:** Sub-Basement Mezzanine- Gym **Description:** Beige Paint On Brick Wall **Laboratory Result (%):** 2.2 % weight **Substrate:** Brick **Paint Locations:** Sub-Basement Mezzanine- Gym	
Sample Numbers: LCP-48 **Sample Location:** Sub-Basement Mezzanine- Gym **Description:** Brown Paint On Metal Door **Laboratory Result (%):** 0.18 % weight **Substrate:** Metal **Paint Locations:** Sub-Basement Mezzanine- Gym
