APPENDIX C

HAZARDOUS MATERIALS

1519 HERKIMER STREET
BROOKLYN, NY
TAX MAP ID: BLOCK 1555, LOT 19

PHASE I
ENVIRONMENTAL SITE ASSESSMENT
(ASTM 1527-13/40 CFR PART 312)

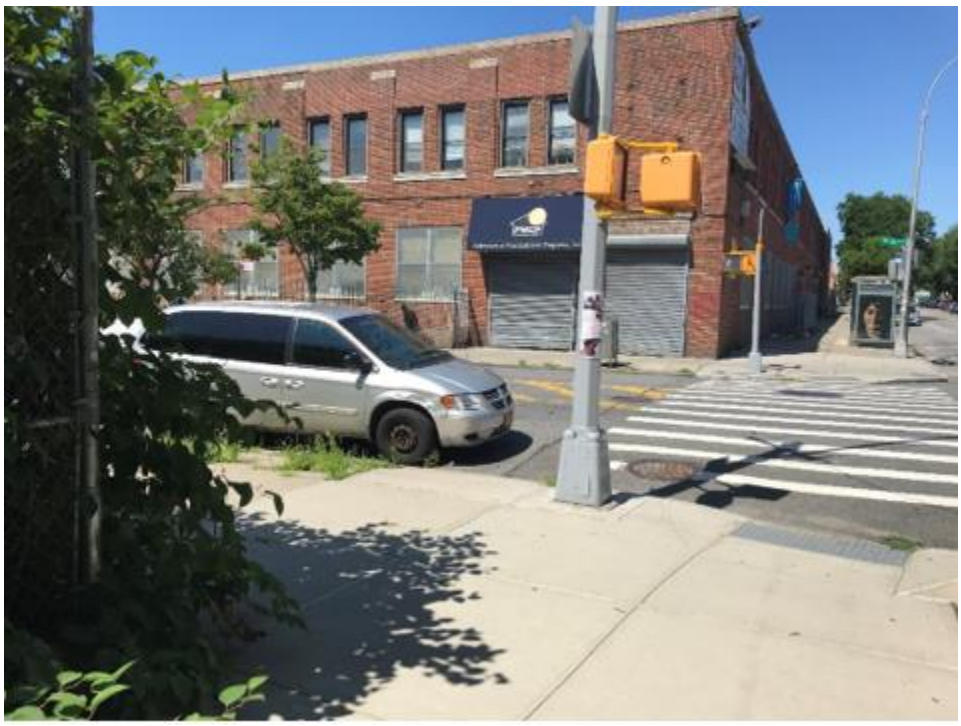
View of nursery/school located west of the subject property, facing southwest.

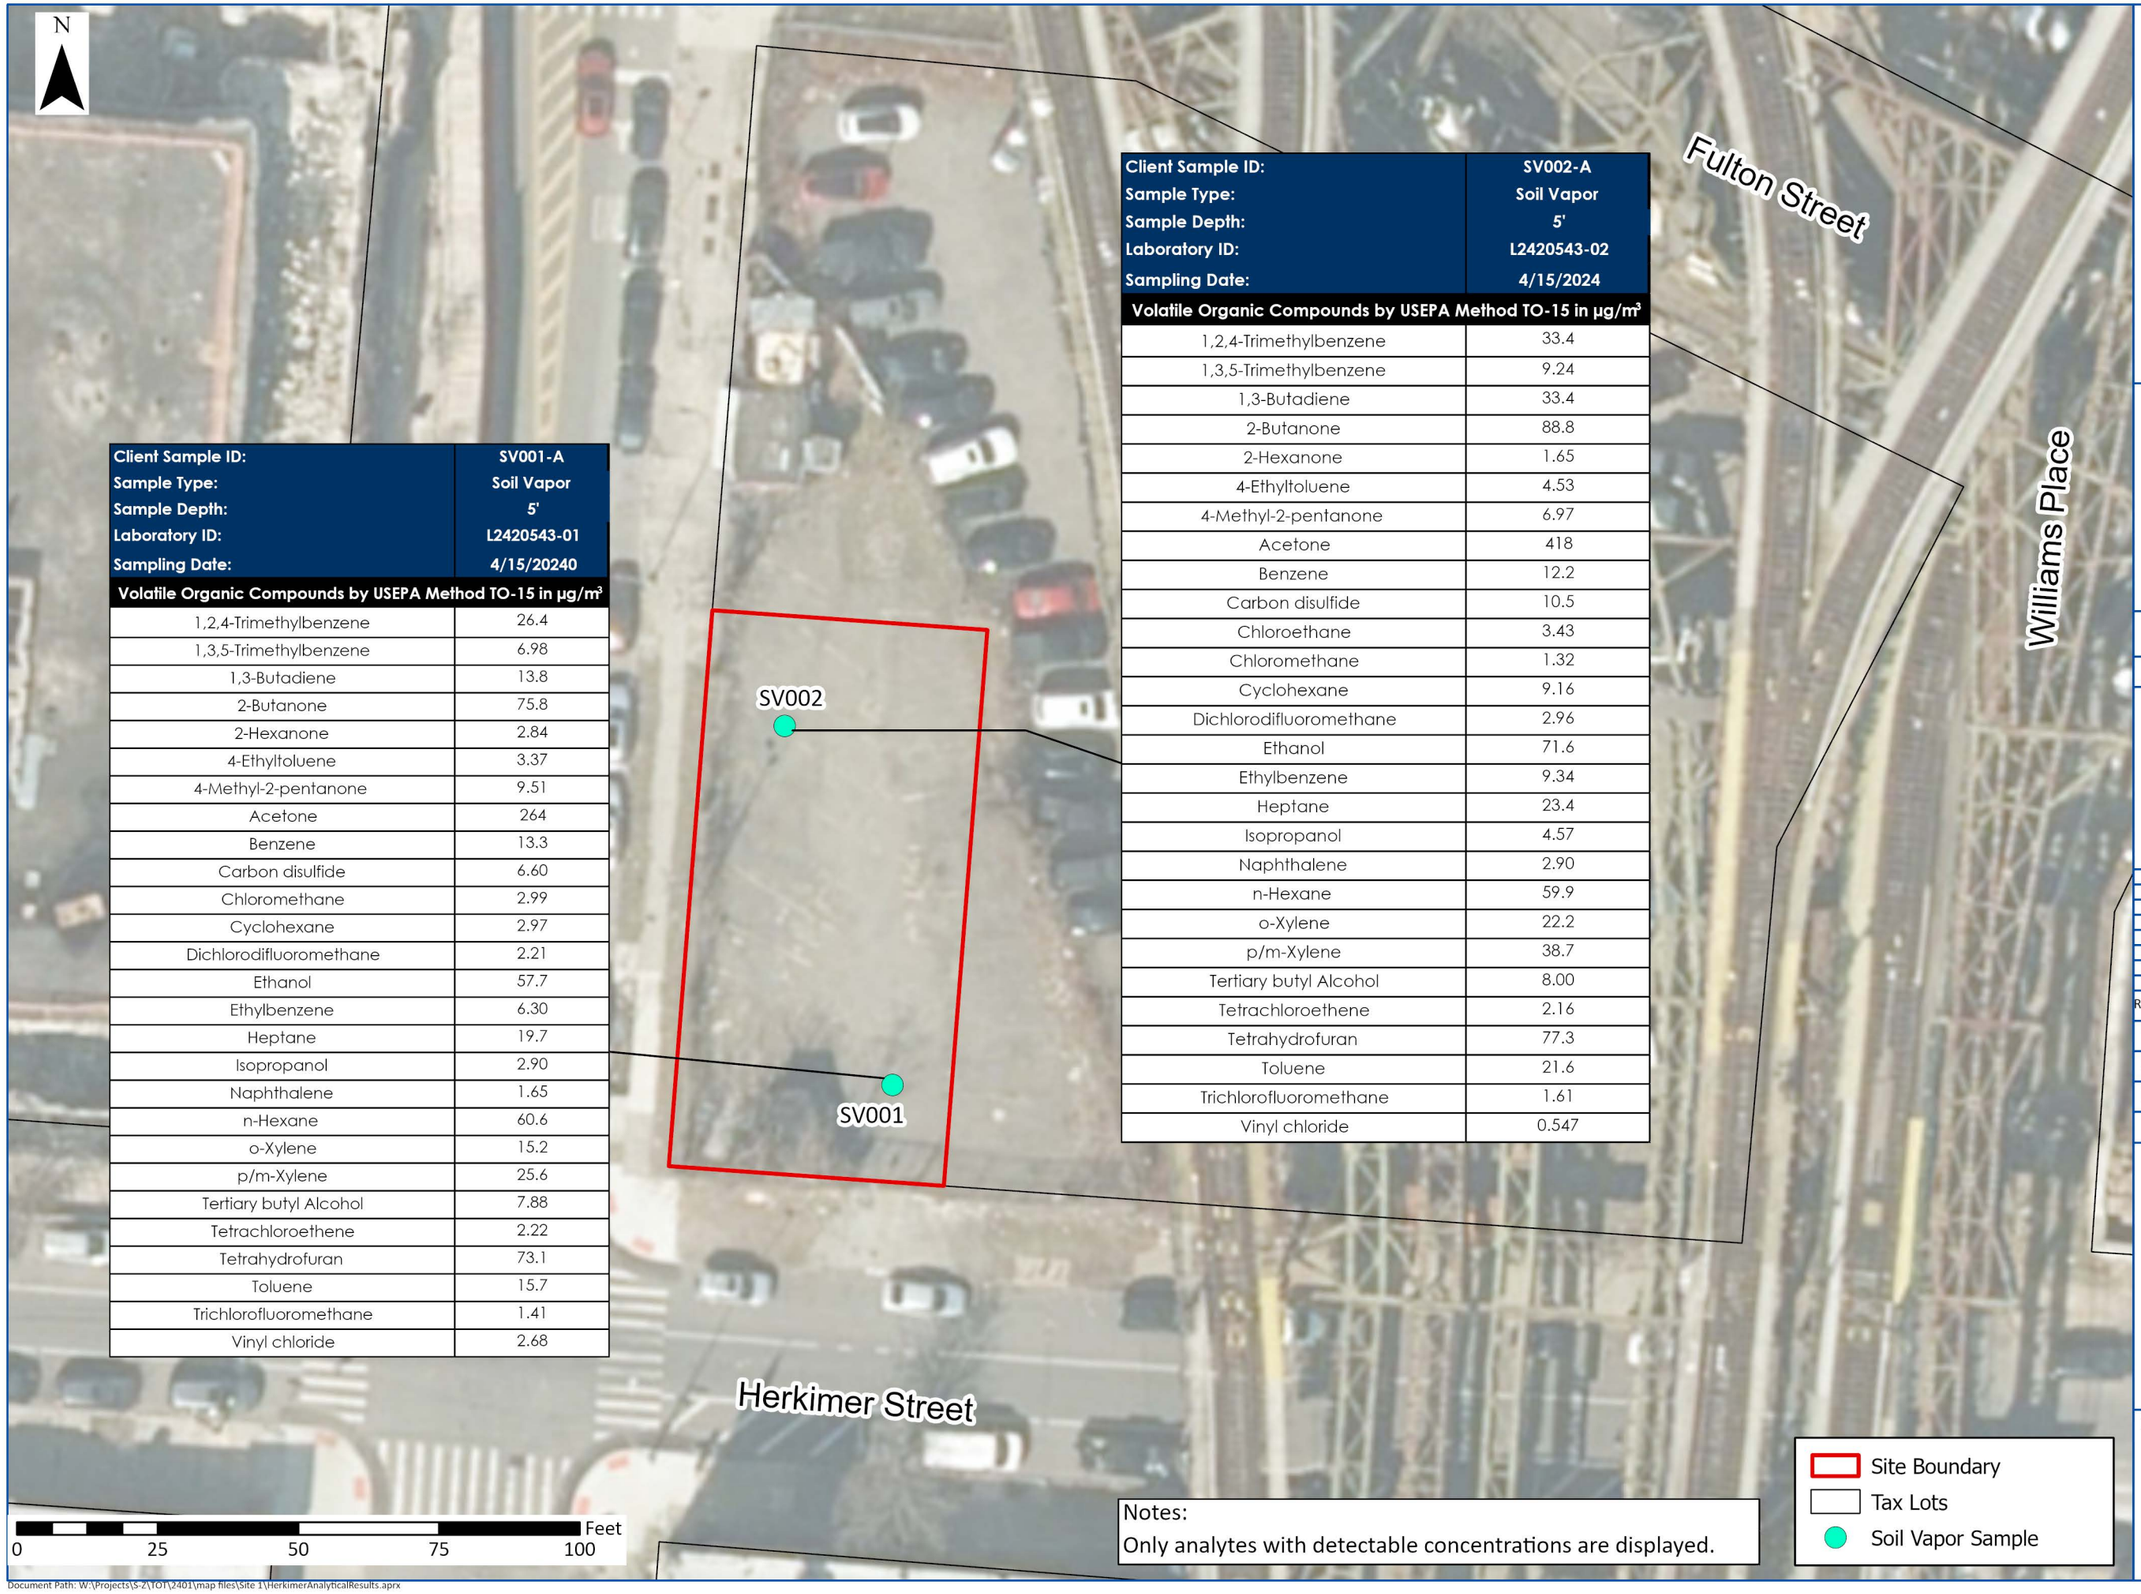
4

Client Sample ID:	SV001-A
Sample Type:	Soil Vapor
Sample Depth:	5'
Laboratory ID:	L2420543-01
Sampling Date:	4/15/20240
Volatile Organic Compounds by USEPA Method TO-15 in µg/m³	
1,2,4-Trimethylbenzene	26.4
1,3,5-Trimethylbenzene	6.98
1,3-Butadiene	13.8
2-Butanone	75.8
2-Hexanone	2.84
4-Ethyltoluene	3.37
4-Methyl-2-pentanone	9.51
Acetone	264
Benzene	13.3
Carbon disulfide	6.60
Chloromethane	2.99
Cyclohexane	2.97
Dichlorodifluoromethane	2.21
Ethanol	57.7
Ethylbenzene	6.30
Heptane	19.7
Isopropanol	2.90
Naphthalene	1.65
n-Hexane	60.6
o-Xylene	15.2
p/m-Xylene	25.6
Tertiary butyl Alcohol	7.88
Tetrachloroethene	2.22
Tetrahydrofuran	73.1
Toluene	15.7
Trichlorofluoromethane	1.41
Vinyl chloride	2.68

Client Sample ID:	SV002-A
Sample Type:	Soil Vapor
Sample Depth:	5'
Laboratory ID:	L2420543-02
Sampling Date:	4/15/2024
Volatile Organic Compounds by USEPA Method TO-15 in µg/m³	
1,2,4-Trimethylbenzene	33.4
1,3,5-Trimethylbenzene	9.24
1,3-Butadiene	33.4
2-Butanone	88.8
2-Hexanone	1.65
4-Ethyltoluene	4.53
4-Methyl-2-pentanone	6.97
Acetone	418
Benzene	12.2
Carbon disulfide	10.5
Chloroethane	3.43
Chloromethane	1.32
Cyclohexane	9.16
Dichlorodifluoromethane	2.96
Ethanol	71.6
Ethylbenzene	9.34
Heptane	23.4
Isopropanol	4.57
Naphthalene	2.90
n-Hexane	59.9
o-Xylene	22.2
p/m-Xylene	38.7
Tertiary butyl Alcohol	8.00
Tetrachloroethene	2.16
Tetrahydrofuran	77.3
Toluene	21.6
Trichlorofluoromethane	1.61
Vinyl chloride	0.547

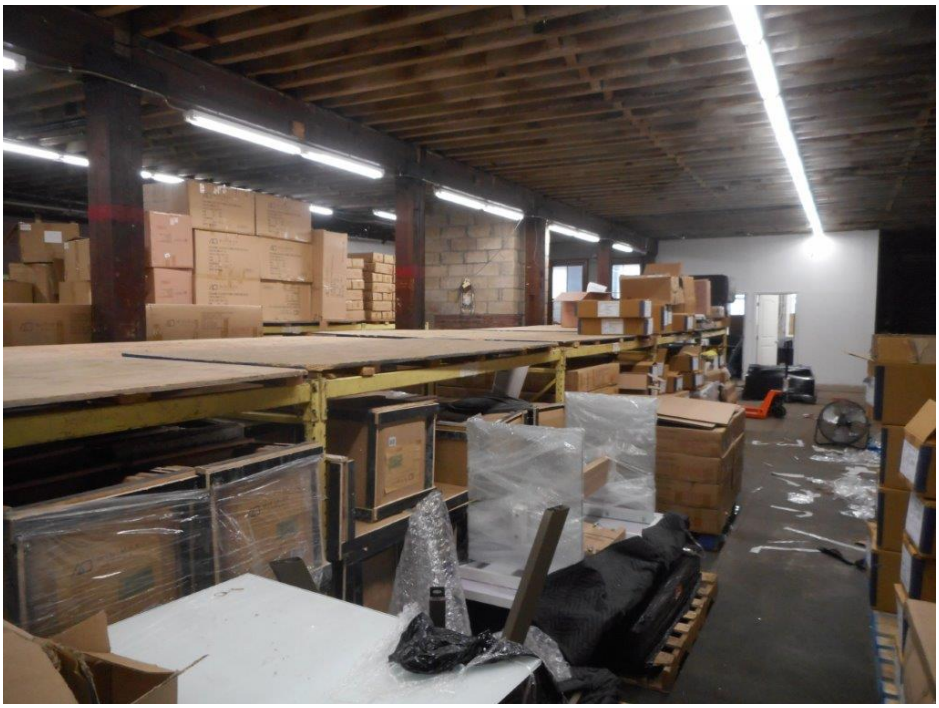
6. Typical warehouse conditions

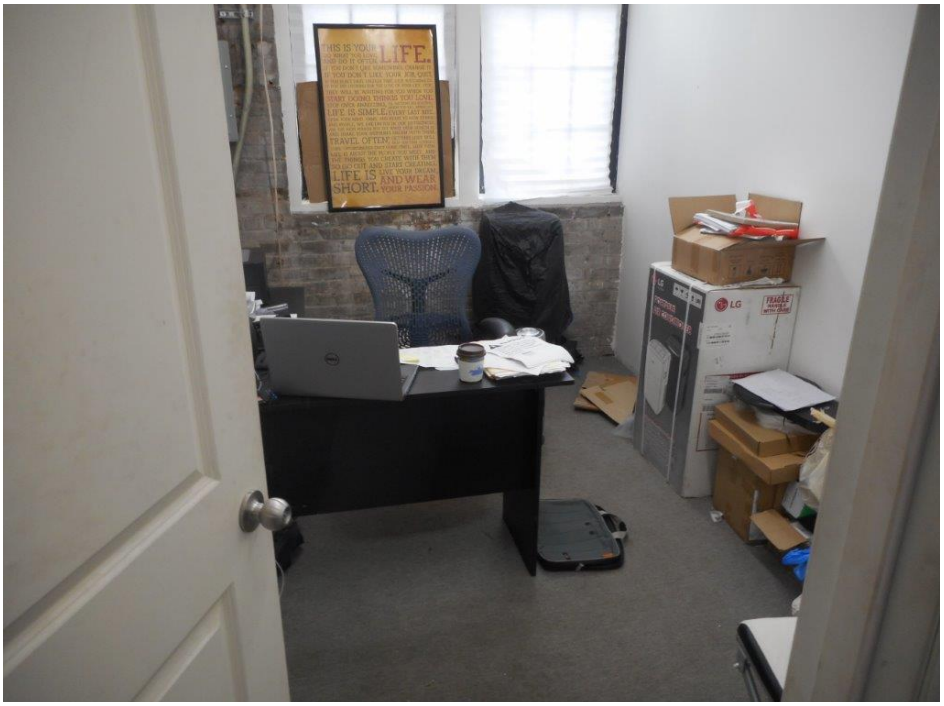
7. Warehousing office conditions

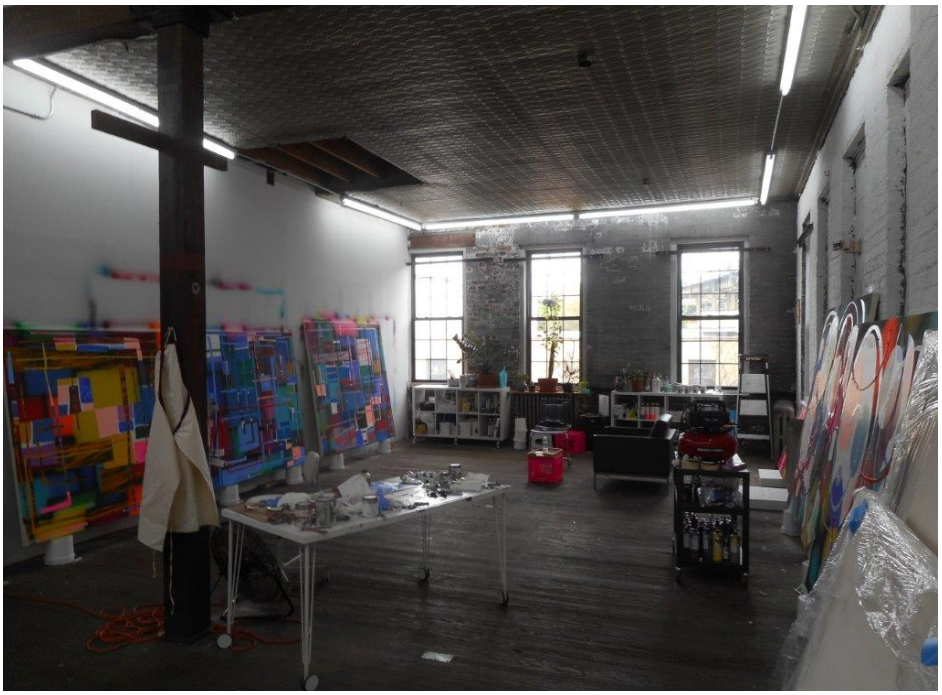
8. Second floor artist loft conditions

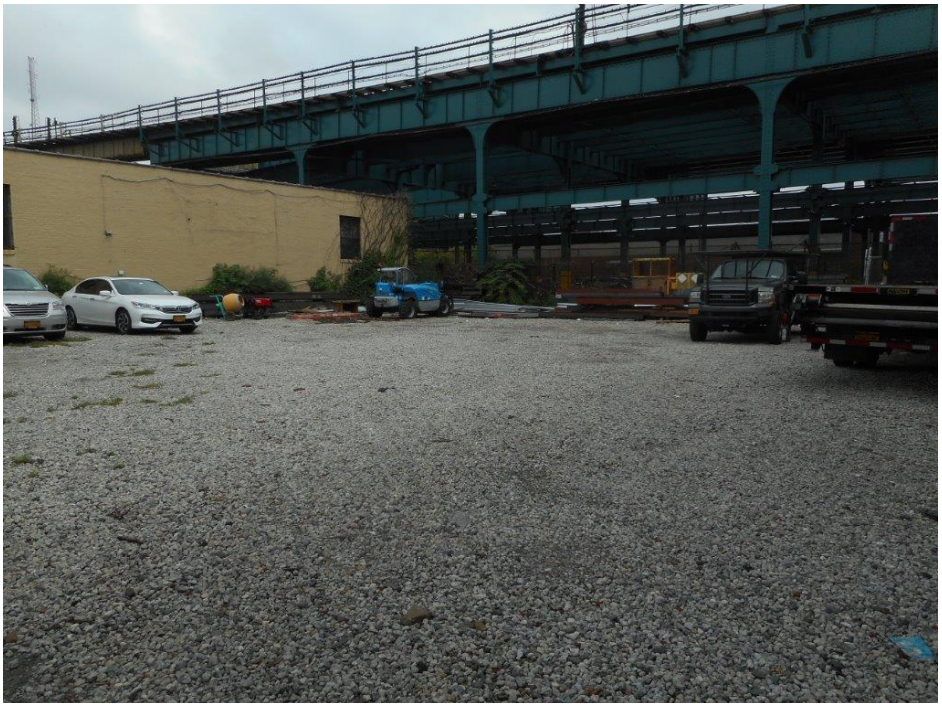
10. Storage yard conditions

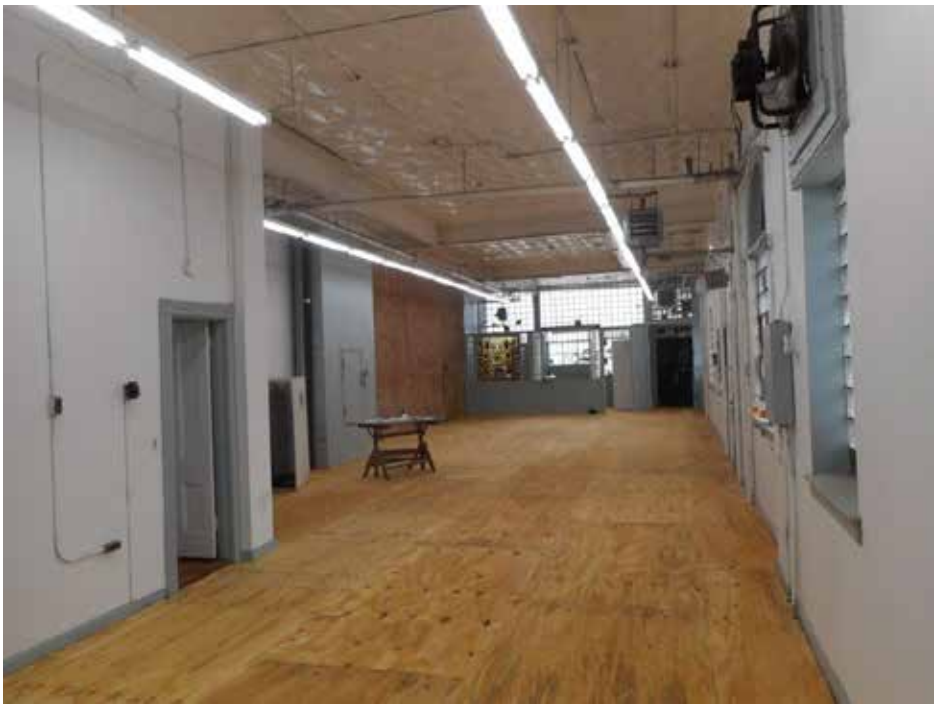
6. Typical vacant loft/office space

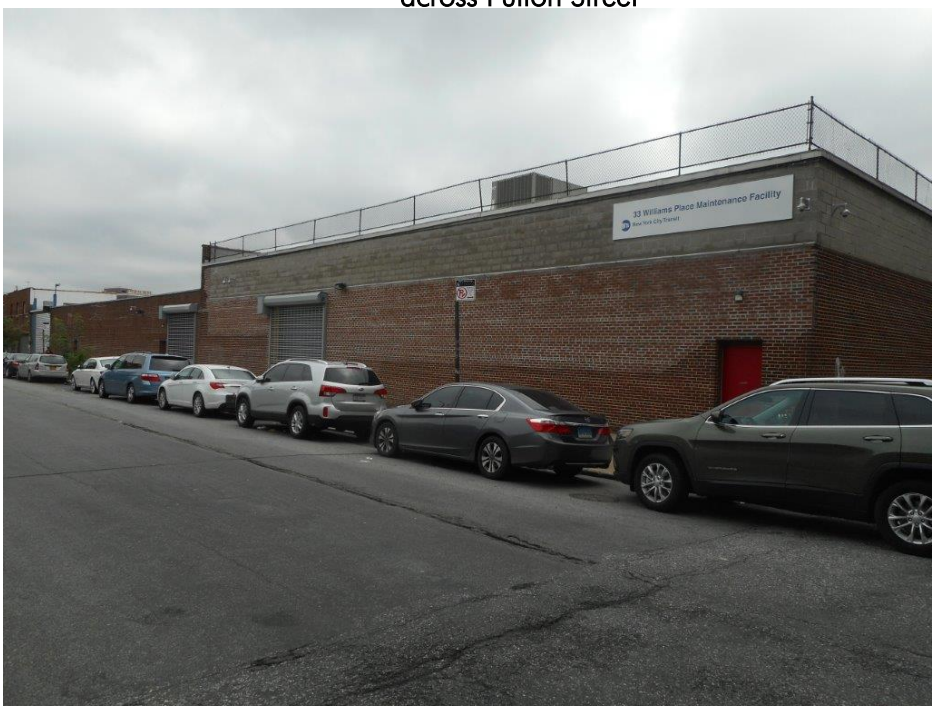
12. South adjacent properties across Herkimer Street
