APPENDIX C

HAZARDOUS MATERIALS

1519 HERKIMER STREET
BROOKLYN, NY
TAX MAP ID: BLOCK 1555, LOT 19

PHASE I
ENVIRONMENTAL SITE ASSESSMENT
(ASTM 1527-13/40 CFR PART 312)

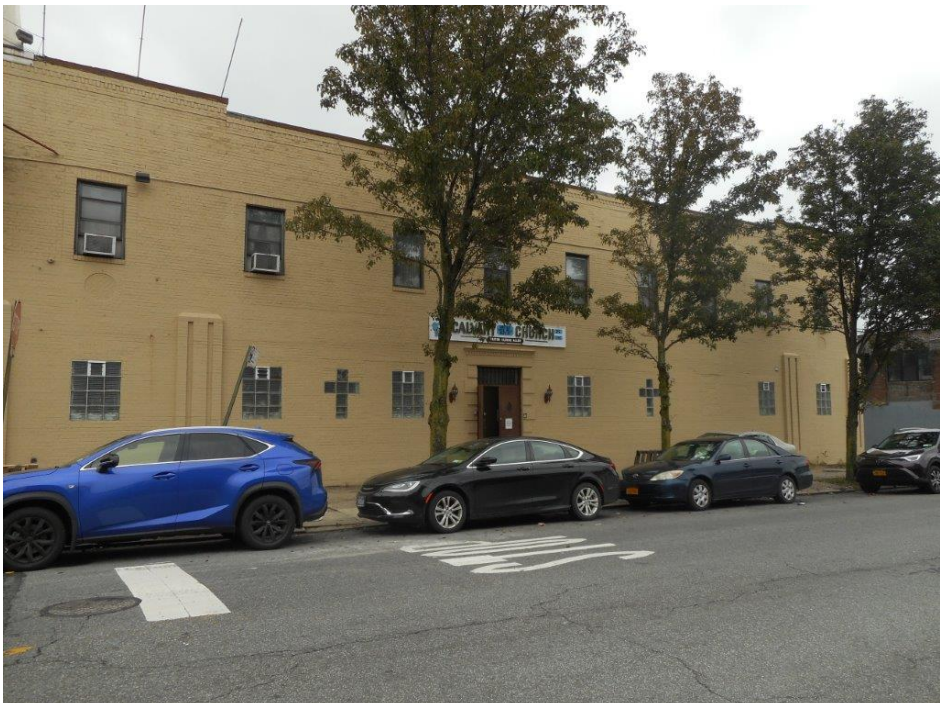
11. North adjacent property along Van Sinderen Avenue
