PHASE I ENVIRONMENTAL SITE ASSESSMENT AND LIMITED PHASE II ENVIRONMENTAL SITE INVESTIGATION

14 Meserole Avenue, 190 & 192 Banker Street, and 26 Gem Street
Brooklyn, New York
Block 2615, Lots 1, 21, 25, and 50

Langan Engineering, Environmental, Surveying, and Landscape Architecture, D.P.C.
21 Penn Plaza
360 West 31st Street, 8th Floor
New York, New York 10001

March 22, 2018
Langan Project No. 170494901

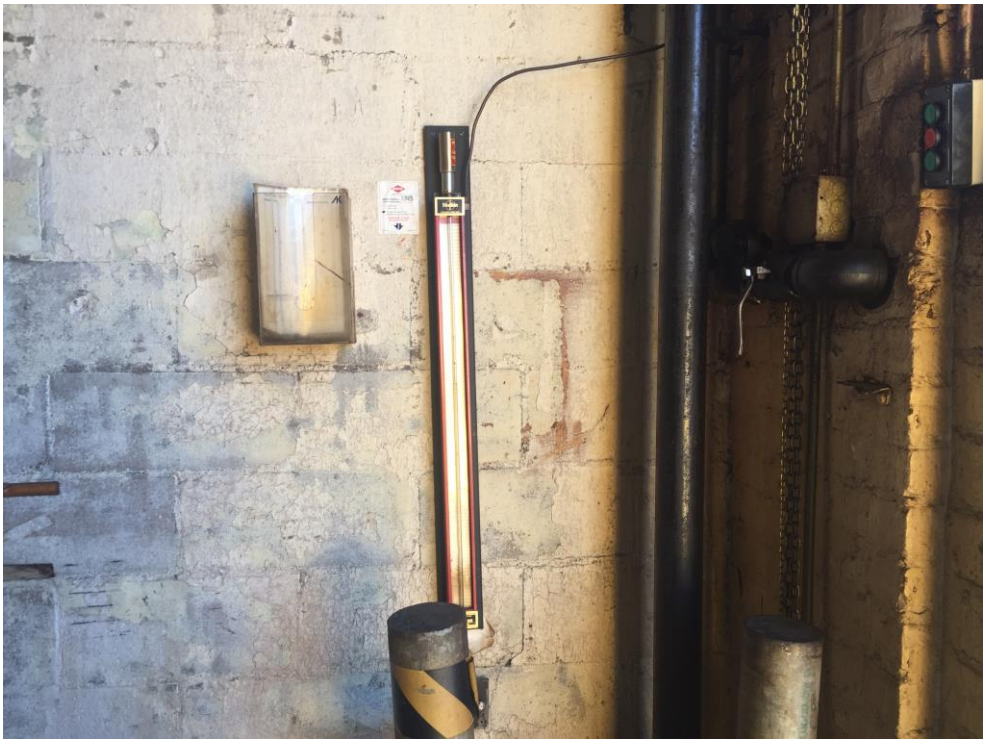
Photograph 11: A petrometer for the 4,000-gallon diesel AST observed on the interior southern wall at the far west side of the building on Lot 21; facing south.

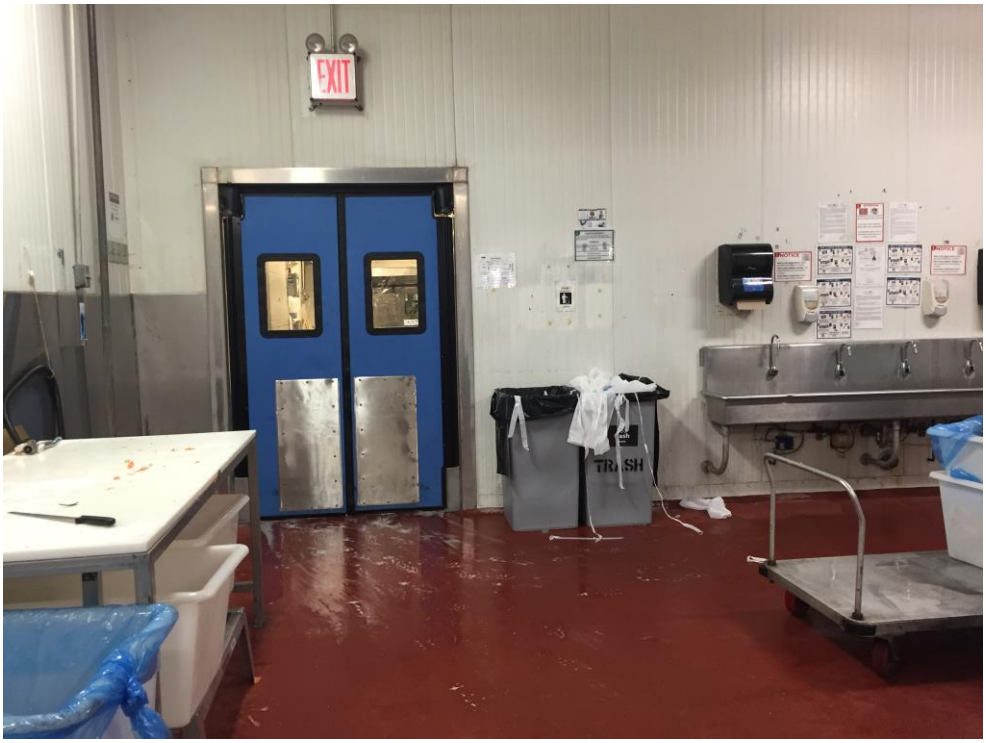
Photograph 18: View of a food preparation area at the eastern side of the building on Lot 1; facing west.

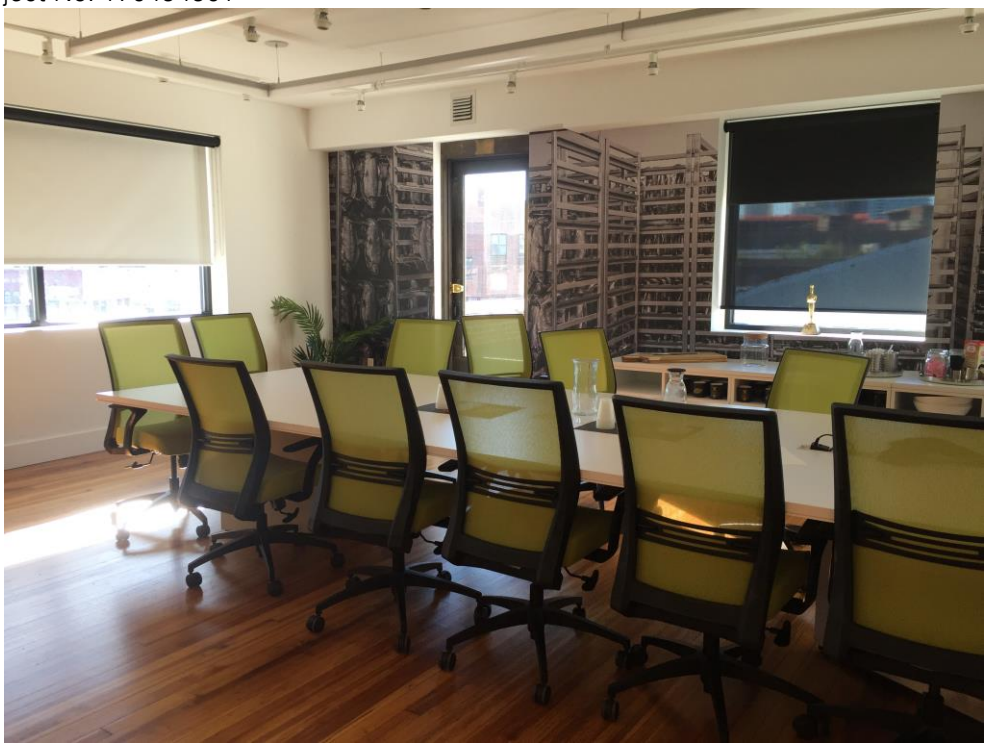
Photograph 23: View of the second-floor offices within the building on Lot 25; facing west.

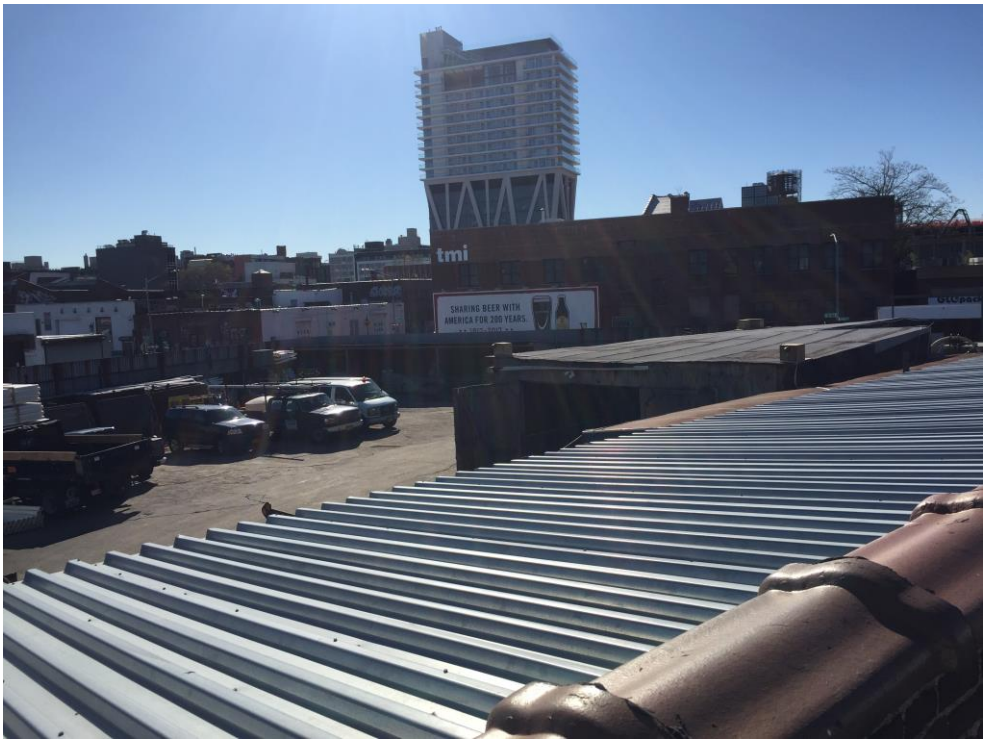
Photograph 24: View of the adjoining property to the south from the roof of the building on Lot 25; facing southwest.

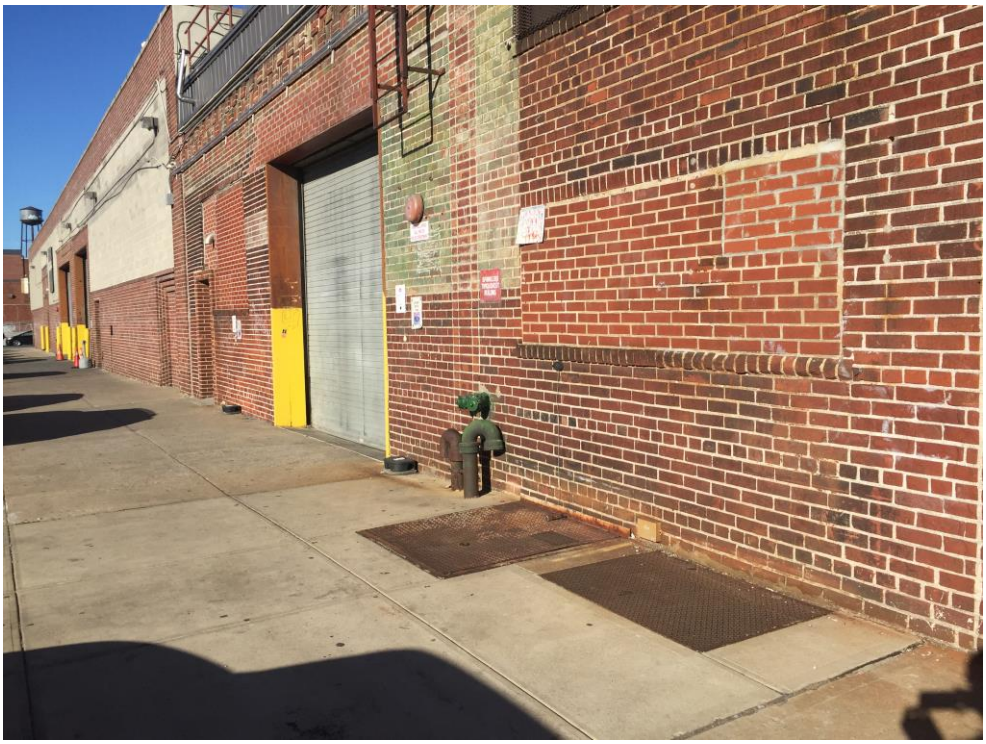
Photograph 26: View of the west façade of the adjoining property to the west; facing northeast.

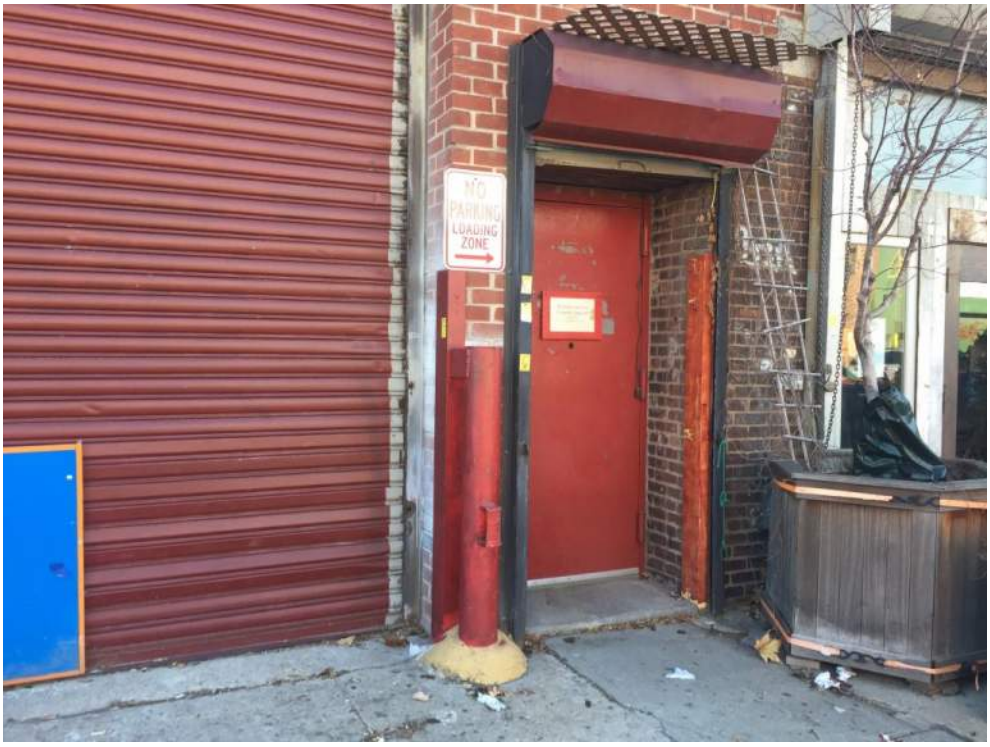
Photograph 1: View of the eastern façades of the Subject Property and the adjoining property to the north; facing northwest.

Photograph 2: View of the eastern façade of the Subject Property; facing west.

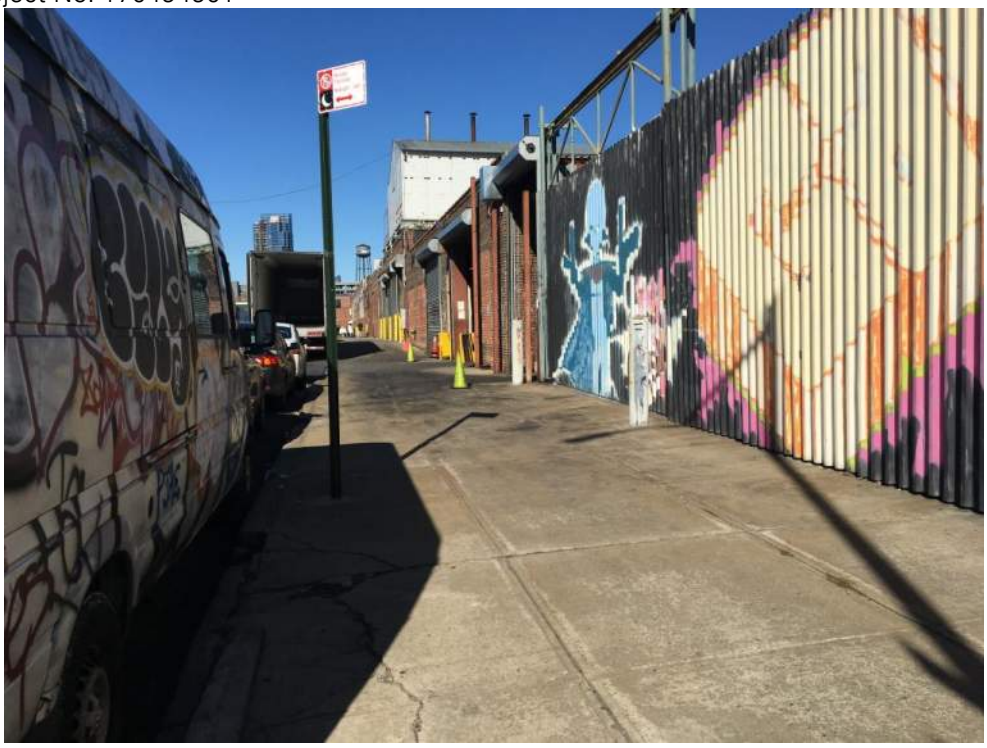
Photograph 4: View of the eastern side of the Subject Property block (Block 2615), Banker Street, and the western side of the block east of the Subject Property (Block 2616); facing north.

Photograph 5: View of the western side of the Subject Property block (Block 2615) and Gem Street; facing north.
